CONNECTICUT RIVER BASIN
GARDNER , MASSACHUSETTS

PERLEY BROOK RESERVOIR DAM
MA 00119

**PHASE I INSPECTION REPORT
NATIONAL DAM INSPECTION PROGRAM**

JUNE 1980

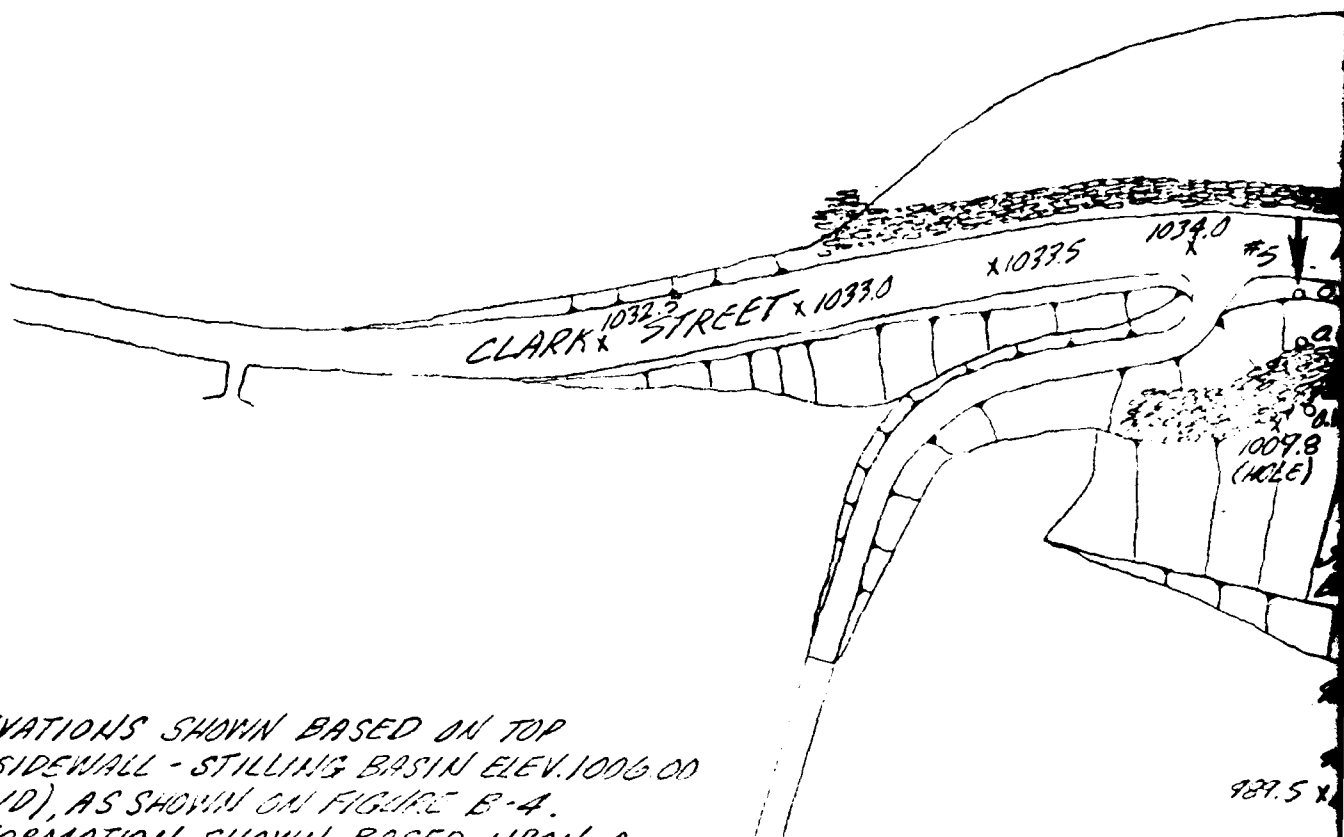
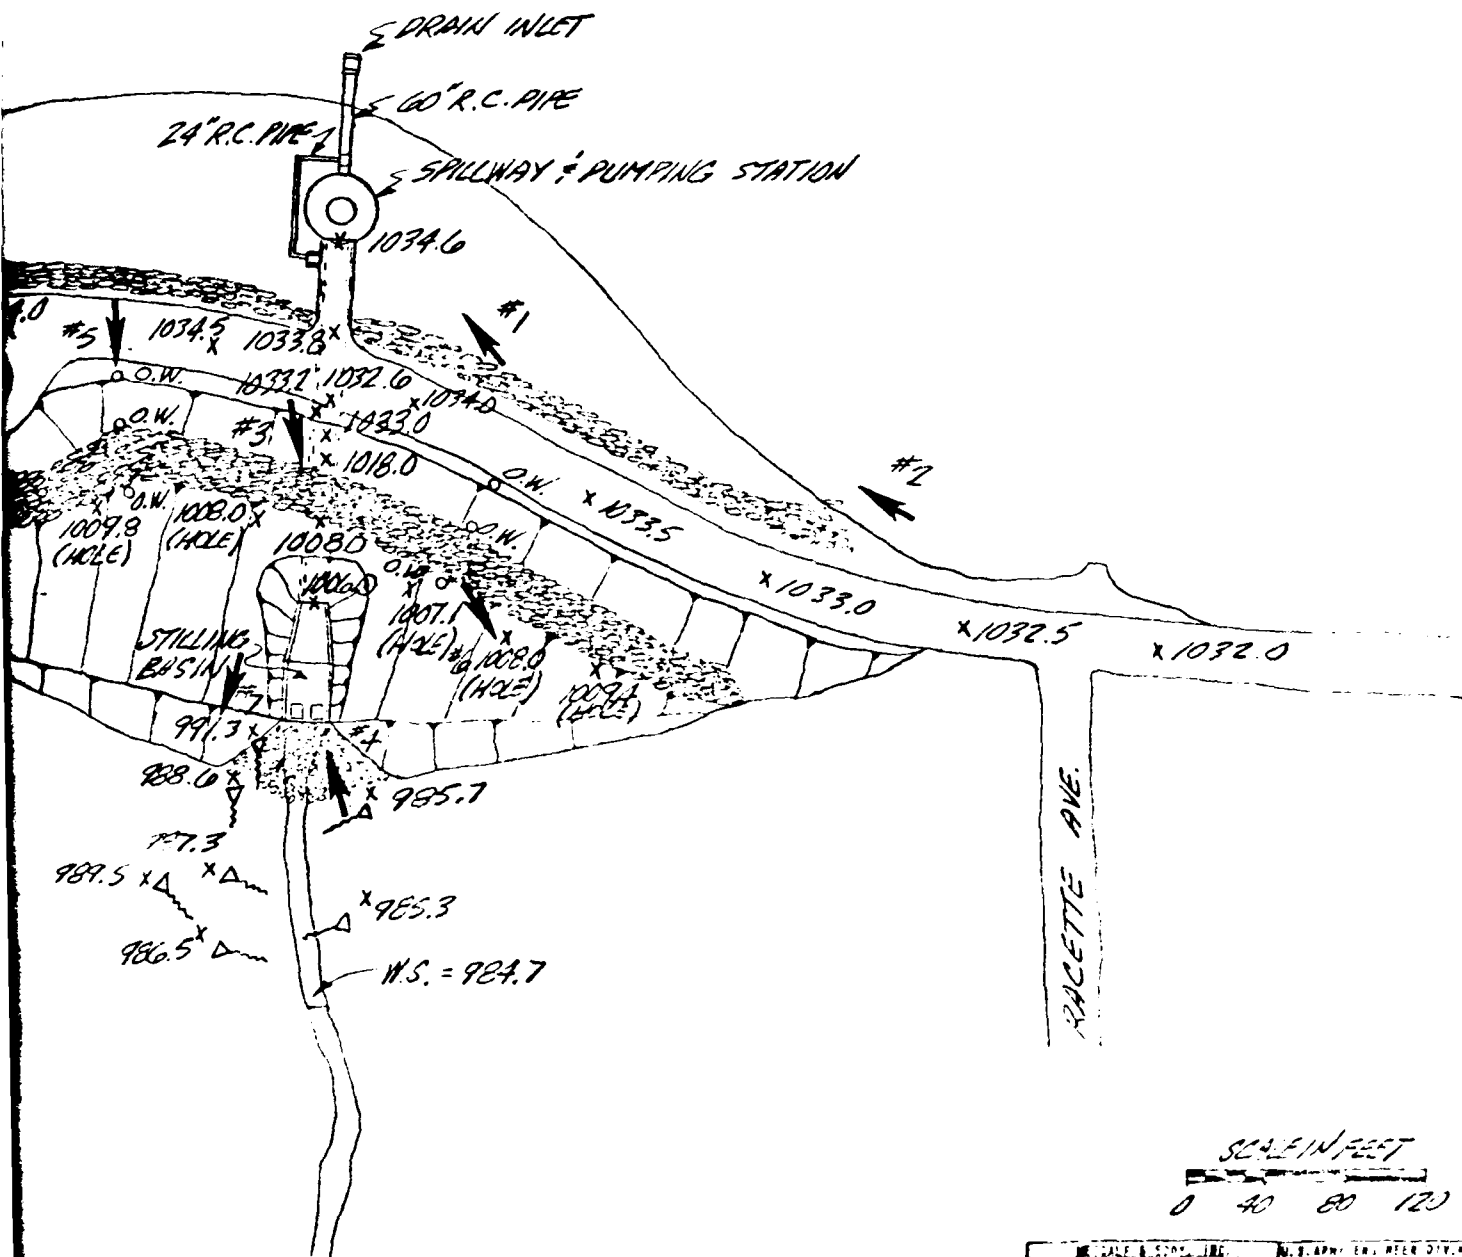
DESIGNED BY M. J. GALE & SONS, INC. NEW HAVEN, CT.	U.S. ARMY CORPS OF ENGINEERS BALTIMORE, MD.
NATIONAL PROGRAM OF INSPECTION OF NON-FED. DAMS	
PERLEY BROOK RESERVOIR DAM	
FIGURE B-1 PLAN OF DAM	
TRIBUTARY CONNECTICUT RIVER	MASSA HILLS S
SCALE: AS SHOWN	DATE: MAY, 1961

1. ELEVATIONS SHOWN BASED ON TOP OF SIDEWALL - STILLING BASIN ELEV. 1006.00 (NGVD), AS SHOWN ON FIGURE B-4.
2. INFORMATION SHOWN BASED UPON A FIELD INSPECTION ON MAY 12, 1980.
3. ∇ INDICATES SEEPAGE.
4. Δ INDICATES LOCATION AND DIRECTION OF VIEW FOR PHOTOGRAPHS.

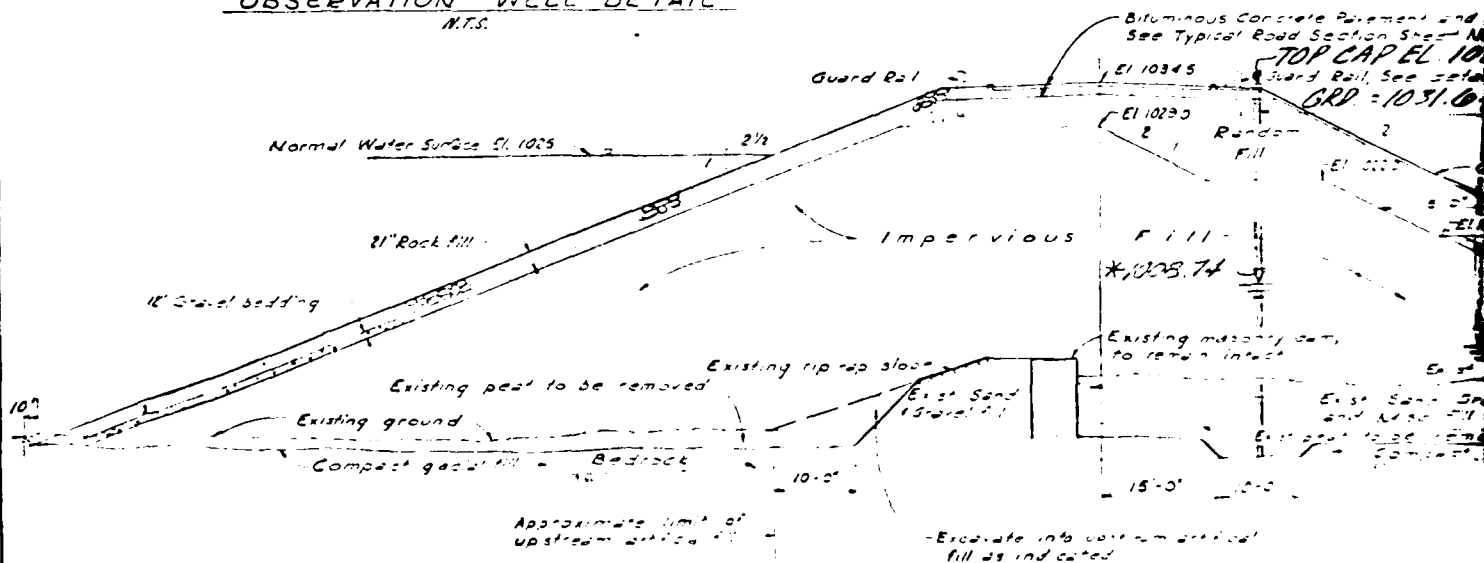
CROSS SECTION @ STA 6+50
Scale: 1" = 10'

1. Water levels in observation wells were measured on 12 May 80.
2. *Elevations verified in field on 12 May 80, and based on an assumed benchmark elevation 1006.0 (NGVD) at top of stilling basin.
